PRIMARY RECORD

* Resource Name or #: 2617 San Marcos Avenue, APN 453-722-02

BUILDING, STRUCTURE, AND OBJECT RECORD

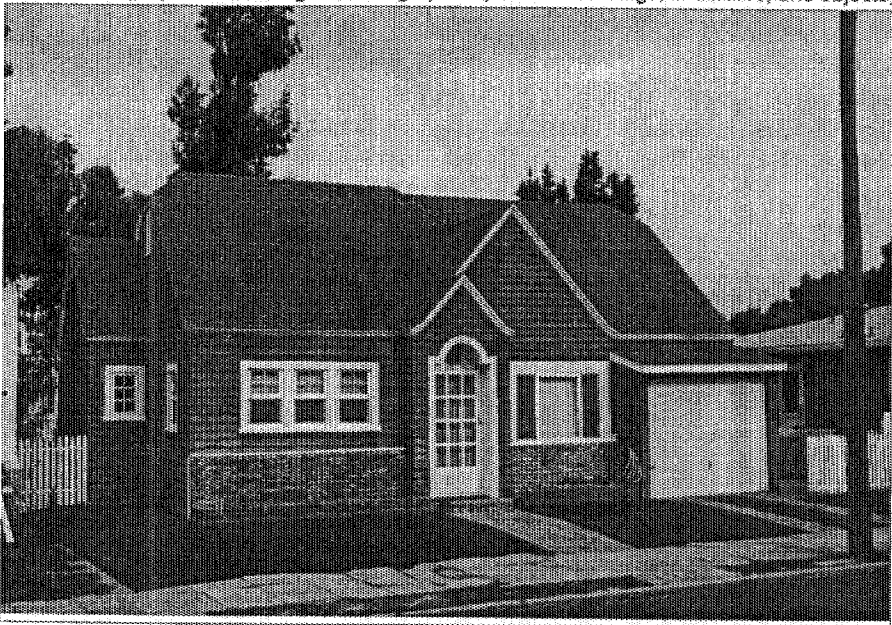
Photo Number: P0003000.JPG Est. Date: 2001

This house was built in 1926 in the Tudor Eclectic style. The house is one and one-half stories with a Jerkinhead hipped side gable roof with intersecting gables sheathed in composite shingles. The exterior wall material is horizontal wood siding and brickwork veneer. The central focal point is a double gable off-centered recessed multi-pane door. The windows are triple section multi-pane double hung windows. The garage door is contemporary. It is in good condition. The total usable floor area is 1,281 square feet. The total lot area is 8,500 square feet.

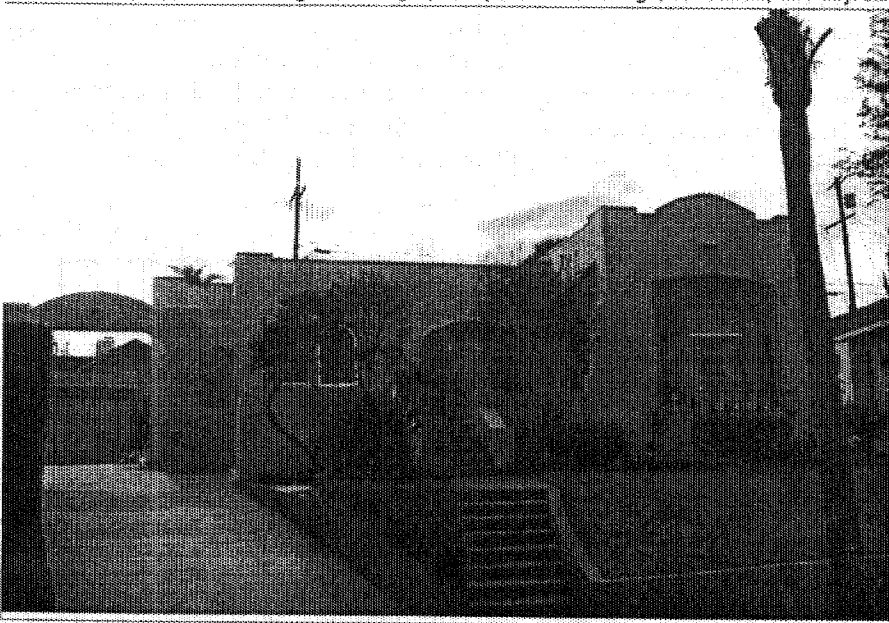
Photo Number: P0003004.JPG Est. Date: 2001

* P3a. Description: (Describe resource and its major elements. Include design, materials, condition, alterations, size, setting, and boundaries.)
This house was built in 1926 in the Mission Revival style. The house is an "L"-shaped one story house with a flat roof, parapet wall, and round vents. The exterior wall material is stucco. The side patio has an arched window and small projecting sloping tiled roof over the arched door. The patio has a pair of multi-light arched casement windows and a triple arched window set under a low-point arch. An attached arched entryway forms the entrance to the porte cochere. The projecting right bay has a pier and pyramid shaped parapet and a central fixed glass casement window with multi-lights on the top and sides set in a low-point arch. The house is nine feet above the sidewalk and is accessed by scored concrete stairs. The house is located in the community of Burlingame. It is in good condition. The total usable floor area is 1,236 square feet. The total lot area is 5,900 square feet.

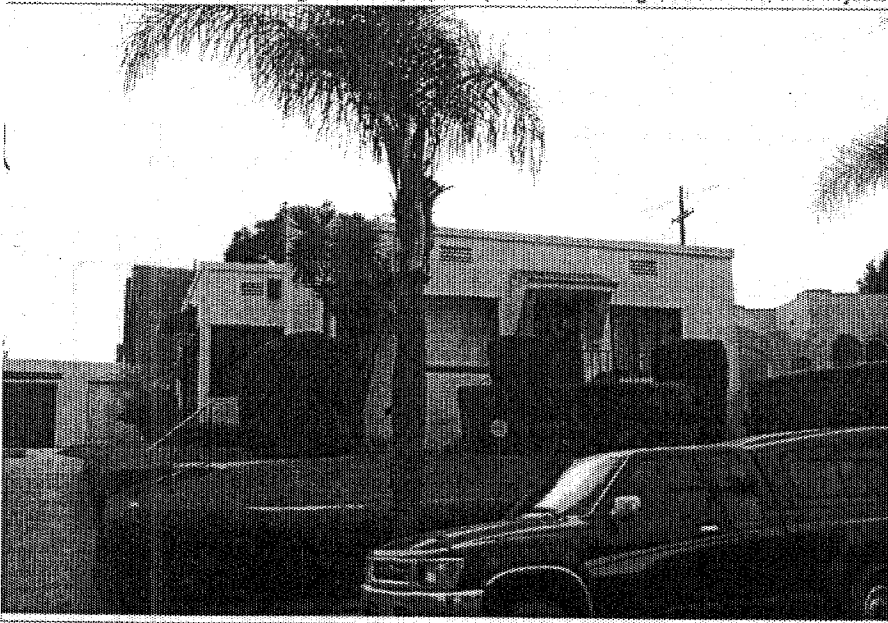
Photo Number: P0003005.JPG Est. Date: 2001

* P3a. Description: (Describe resource and its major elements. Include design, materials, condition, alterations, size, setting, and boundaries.)
This house was built in 1945 in the Spanish Colonial Revival style. The house is one story with a flat roof, parapet walls, symmetrical horizontal vents, and a tapered chimney on the side of the house. The exterior wall material is stucco. The roof parapet has rectangular stucco coping. The central entry has a projecting shed clay tile roof over the door supported by stucco brackets. The entry is flanked by a single fixed pane window to the left, and a three section window with multi-lights on top to the right. All windows appear to be original wood sash. The rear portion of the house, which has a secondary entrance, is offset and projects on the side. The side door has a projecting metal awning which is reversible. The security bars on the doors blend with the house. An addition has been added to the rear garage, which appears to be a living area with aluminum sliding doors. The house is located in the community of Burlingame. It is in good condition. The total usable floor area is 1,331 square feet. The total lot area is 5,200 square feet.
